DMM Mamba test report

A DMM Mamba karabiner plus captive sling was sent to the Technical Committee for testing. The unit had been used as in situ protection at a climbing wall, and had been replaced as part of a maintenance schedule by Bendcrete, the wall manufacturer and service agent.

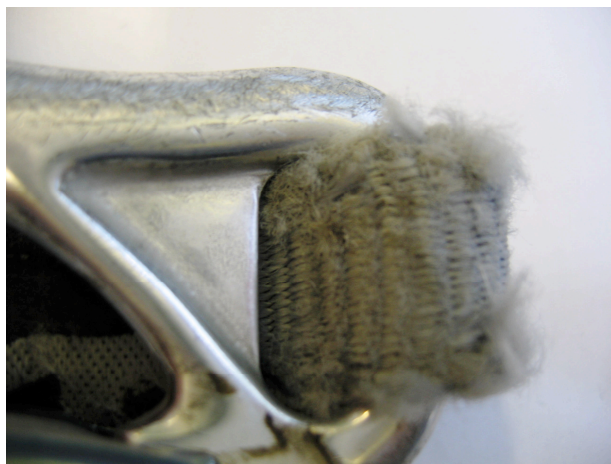
A brief visual inspection of the karabiner found that it was fully functional, but with some wear on the body of the karabiner. This wear was probably caused by rubbing against the climbing wall surface, but was not in a critical area. The sling was quite badly worn around the captive connection point, again most likely from contact with the wall surface.

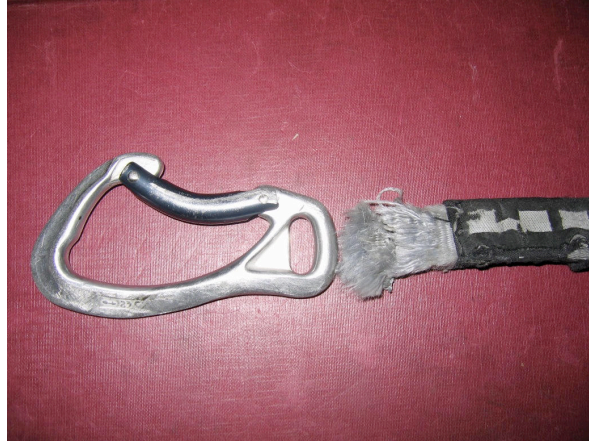
The unit was tested complete at Lyon Equipment, using their tensile test apparatus. Test speed was 50 mm/min using 12mm diameter pins set at 90° to each other. The sling broke at the captive end at 12kN breaking load. The karabiner remains fully

functional with a smooth gate action, and even after testing is likely to remain suitable to use (not that we are recommending this!)

In conclusion, the sling component of this DMM Mamba was found to be worn, to the extent that it may have failed in a worst case climbing wall fall. Regular inspection and, where necessary, replacement of protection points is an important part of any climbing wall safety regime. This test amply demonstrates how textile components can be affected greatly by wear compared to metal components which are often far longer lasting.
