DMM Mamba test report

A DMM Mamba karabiner plus captive sling was sent to the Technical Committee for testing. The unit had been used as in situ protection at a climbing wall, and had been replaced as part of a maintenance schedule by Bendcrete, the wall manufacturer and service agent.

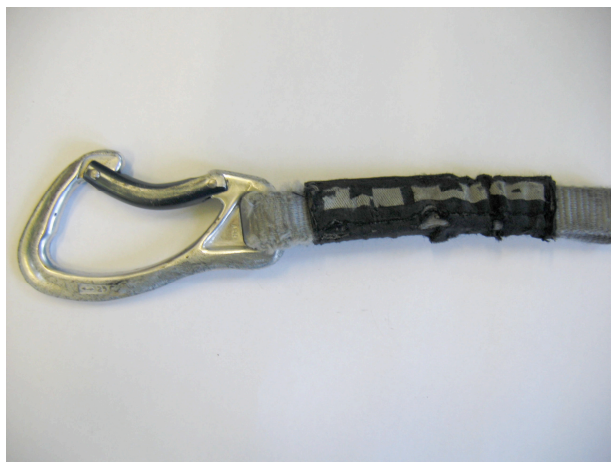
A brief visual inspection of the karabiner found that it was fully functional, but with some wear on the body of the karabiner. This wear was probably caused by rubbing against the climbing wall surface, but was not in a critical area. The sling was quite badly worn around the captive connection point, again most likely from contact with the wall surface.

The unit was tested complete at Lyon Equipment, using their tensile test apparatus. Test speed was 50 mm/min using 12mm diameter pins set at 90° to each other. The sling broke at the captive end at 12kN breaking load. The karabiner remains fully

In conclusion, the sling component of this DMM Mamba was found to be worn, to the extent that it may have failed in a worst case climbing wall fall. Regular inspection and, where necessary, replacement of protection points is an important part of any climbing wall safety regime. This test amply demonstrates how textile components can be affected greatly by wear compared to metal components which are often far longer lasting.
